DOT-VNTSC-FRA-02-06

U.S. Department
of Transportation
**Federal Railroad
Administration**

Vibration Characteristics of the Transrapid TR08 Maglev System

March 2002

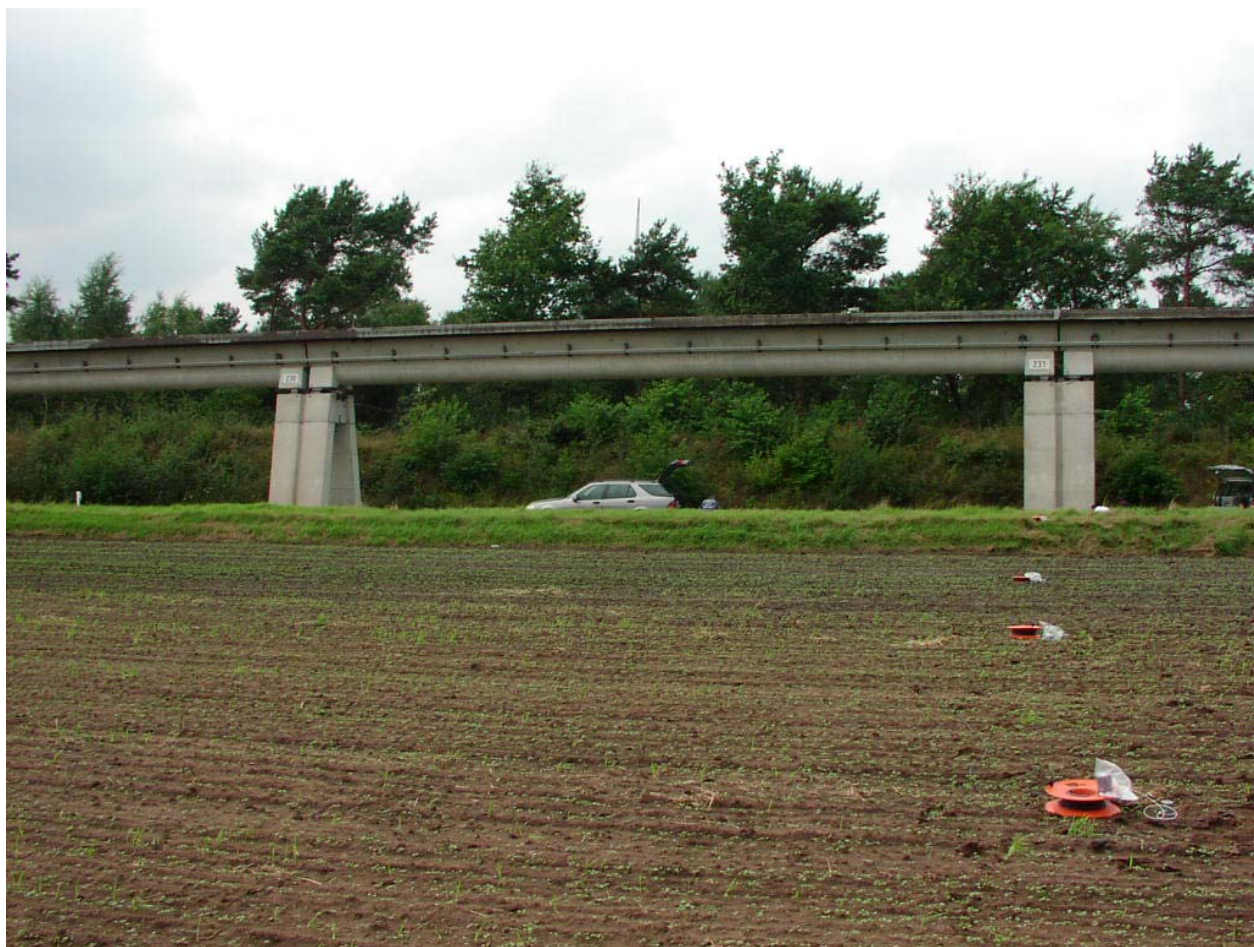
Figure 2-2. Beam 231 (Concrete) Site

adjacent to the concrete and steel beams was a recently harvested potato field, newly planted with a cover crop. The field adjacent to the hybrid beam appeared to have been a recently harvested grain field. Figure 2-2 shows the general field conditions where the vibration transducers were mounted for these beams.

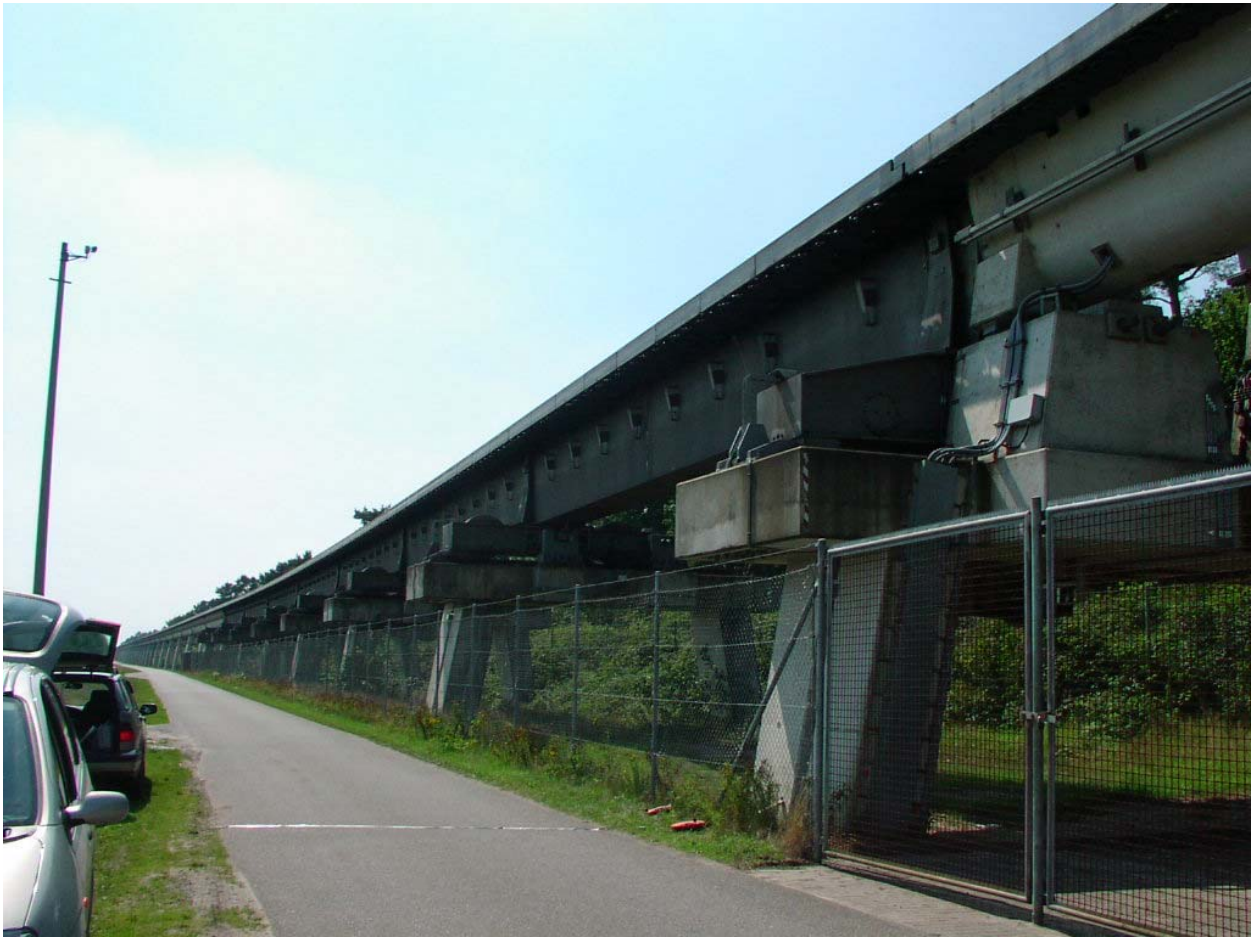
Figure 2-3. High-speed Switch Site

The *high-speed switch* is a flexible steel switch that diverts the northbound maglev vehicle on a turnout to the north loop, then moves back to accommodate the through movement onto the high-speed straight section. The switch consists of a continuous steel beam, anchored at the end adjoining the straight section and moveable at the other end with an electro-mechanical actuated drive system. Adjacent to the switch is the paved access road. Between the road and the farm field is a water-filled drainage ditch. The crop in the field was potato plants about waist-high and ready for harvest. Again the soil appeared to be rich, dark, and well-tilled, with no evidence of surface rock or ledge. The site of the high-speed switch is shown in Figure 2-3.

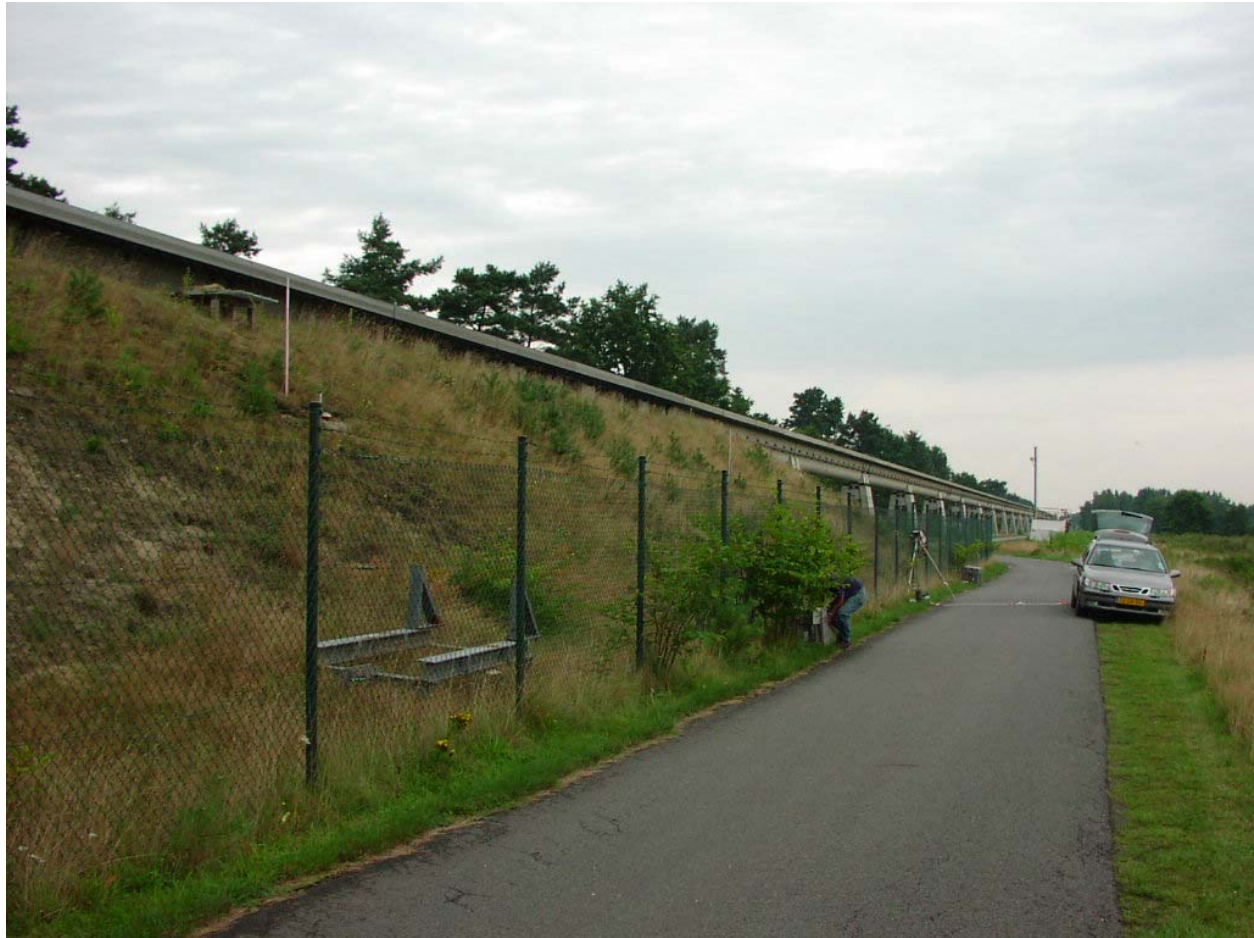
Figure 2-4. “At-grade” Guideway Site

The *at-grade section* is actually an embankment of soil built up to the level of the guideway in the high-speed section of the north loop. Two guideway types are placed on the embankment, a steel beam and a concrete beam, each 25 meters (82.0 feet) long. Measurements of ground-borne vibrations near the two at-grade beams were limited by the size of the embankment leading from ground level to the base of the beam supports (see Figure 2-4). The area around these two beams was fenced, making access difficult. The soil on the embankment appears to be a sandy clay, not the same as the ground in the nearby farm fields. Adjacent to the embankment is the paved access road. Beyond the road is a drainage ditch separating the road from the fields.
